Product Safety Recall

N212338110 Airbag Light May Not Indicate Malfunction

Release Date: June 2021

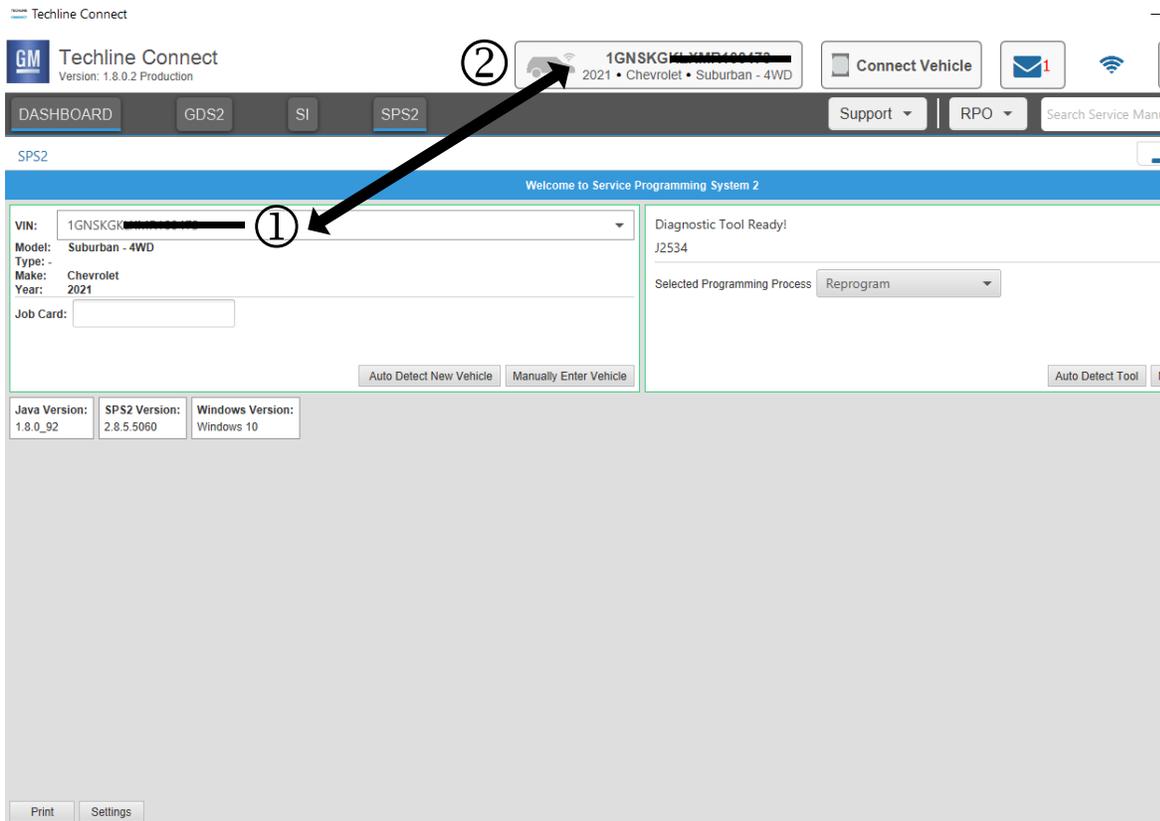
5743643

Caution: Be sure the VIN selected in the drop down menu (1) is the same as the vehicle connected (2) before beginning programming.

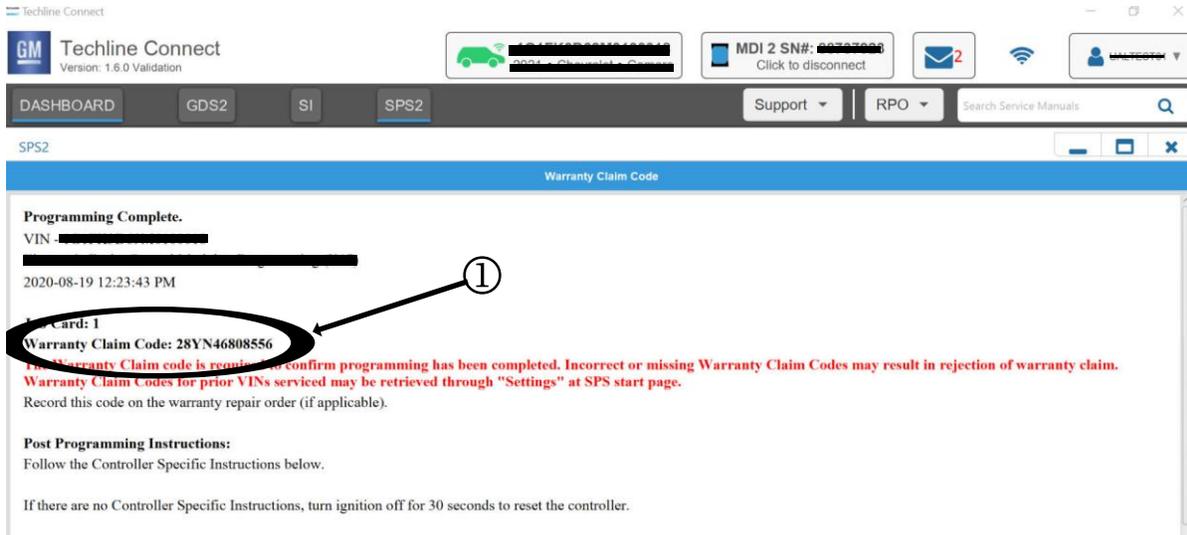
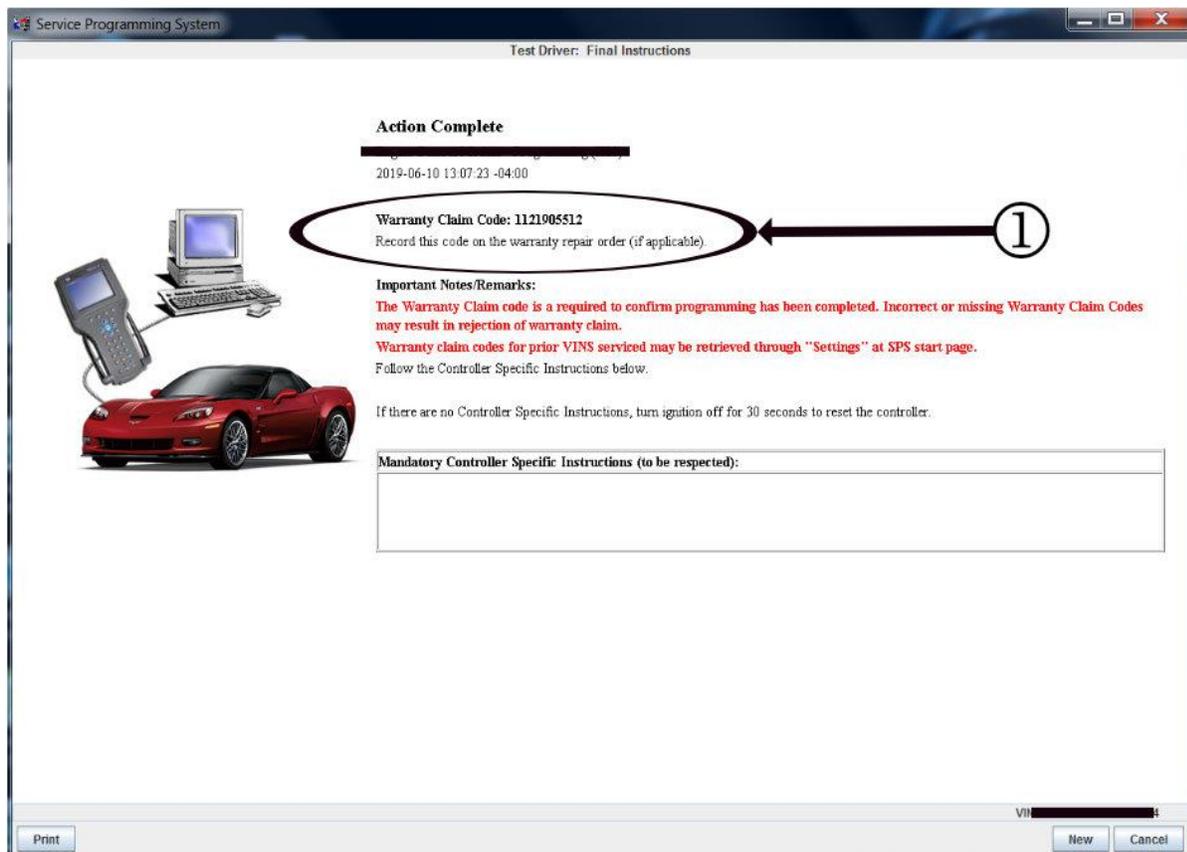
Note: The screenshots above are an example of module programming and may not be indicative of the specific module that is being programmed. Module selection and VIN information have been blacked out.

Important: To avoid warranty transaction rejections, you MUST record the warranty claim code provided on the Warranty Claim Code (WCC) screen shown above on the job card. Refer to callout 1 above for the location of the WCC on the screen.

1. Reprogram the serial data gateway module. Refer to *K56 Serial Data Gateway Module: Programming and Setup* in SI.
